August 14, 2015

**CITY OF FORT WAYNE  
RIPARIAN MANAGEMENT PLAN  
*FINAL***

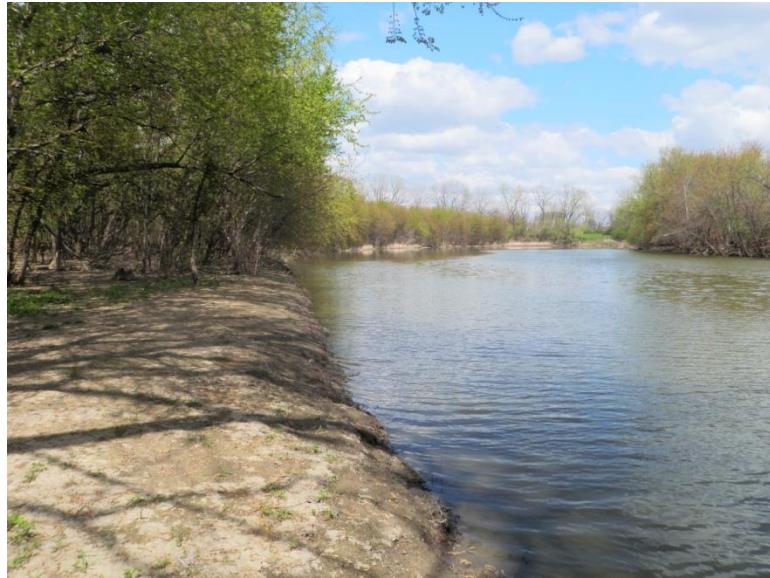
Most of Bloomingdale Park's streambanks, which are located on an outside meander bend of the St. Marys River, are composed of low to moderate bank angles and are well vegetated. At the downstream end, where the bank changes to a steeper angle, there is one area (site 2, see Appendix A) of active streambank erosion which is located approximately 500 feet upstream of the Ewing Street Bridge. It is on the left bank, on the outside of a meander of the St. Marys River, and about 50 feet long. The bank has vegetation growing on the upper third of its height, but the bottom two thirds are eroding. The existing vegetation in this area is mostly shrubs and younger trees, with minimal herbaceous cover.

**Figure 1.4. Shoreline and riparian conditions in the Bloomingdale Park floodplain (Source: Biohabitats; April 30, 2015).**

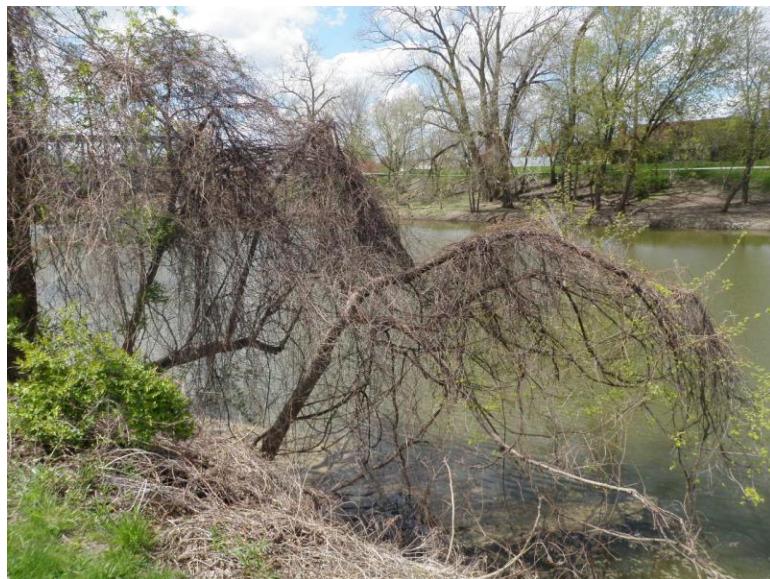
Figure 2.8. Grape vine damage to riparian vegetation (Source: Biohabitats; April 30, 2015).

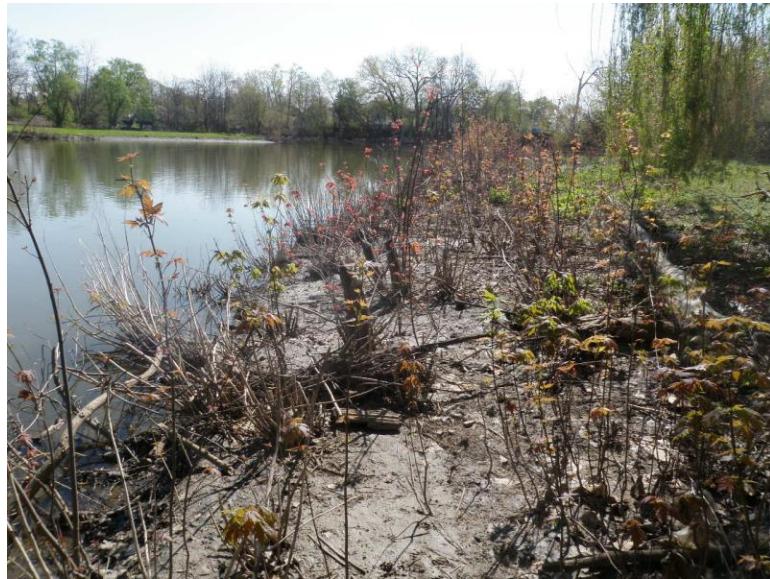
**Figure 2.14. Herbivory of silver maples in Headwaters Park**  
**(Source: Biohabitats; April 30, 2015).**

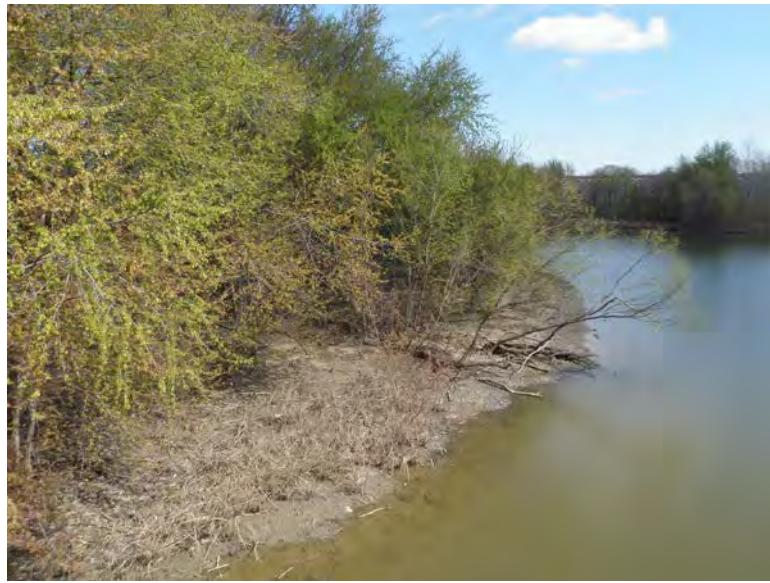
**Figure 3.1. Typical floodplain bench with silver maple floodplain forest**  
**(Source: Biohabitats; April 30, 2015).**

The floodplain benches within the study area are typically dominated by an even-aged stand of silver maple ~75 feet tall with almost no understory, regeneration or diversity. The lack of regeneration can be attributed to heavy sedimentation, which hinders seed establishment, yearly drawdowns which alter the hyrdoperiod, and herbivory from beaver and geese.

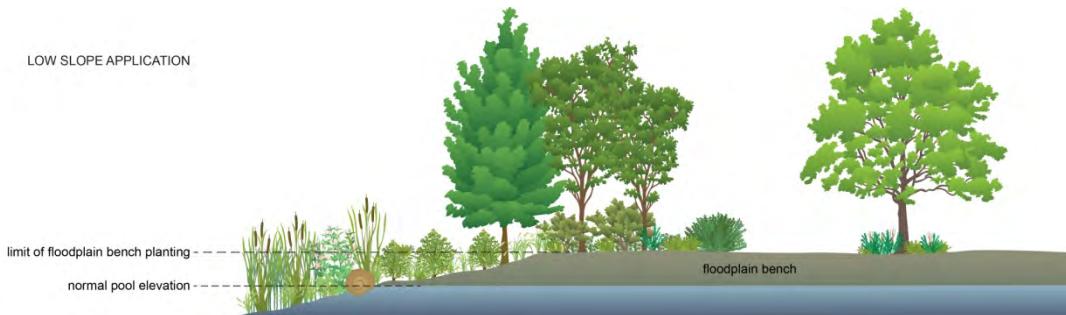
**Figure 3.2. Floodplain bench restoration approach (Source: Biohabitats; August 4, 2015).**

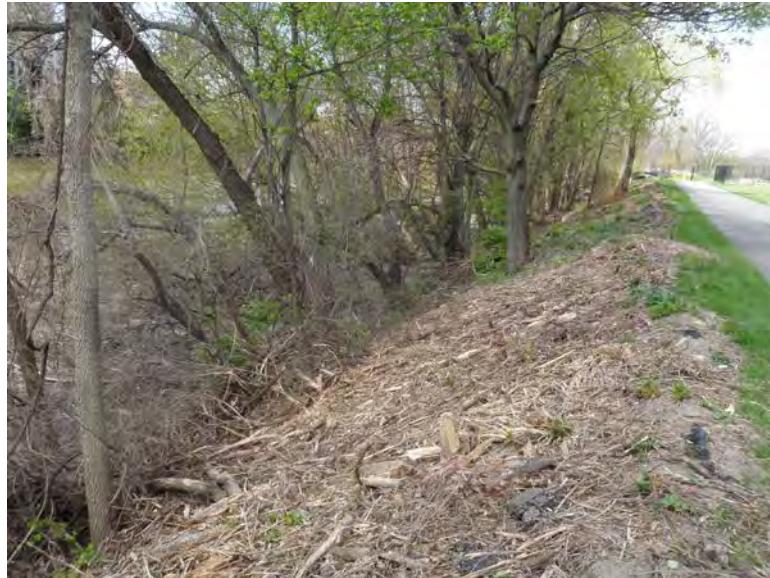
The majority of the streambanks and riparian areas within the study area fall into two categories, low floodplain benches and slopes. The slopes can vary greatly in their steepness from gradual to near vertical. These areas are typically not subject to the extreme conditions that the floodplain benches receive. Although the lower elevations of slopes will still experience high flows, woody debris, ice and some sedimentation, these effects are mainly concentrated on the toe of the slope. With higher elevations and fewer stressors, the slope can support a more diverse plant palate in general. Nevertheless, with the narrow riparian buffers within the study area and the urban context, the existing vegetative community diversity is limited and is dominated by an invasive understory of honeysuckle (*Lonicera sp.*), see table 3.4.

**Figure 3.3. Typical riparian slope with cleared honeysuckle in foreground**  
 (Source: Biohabitats; April 30, 2015).

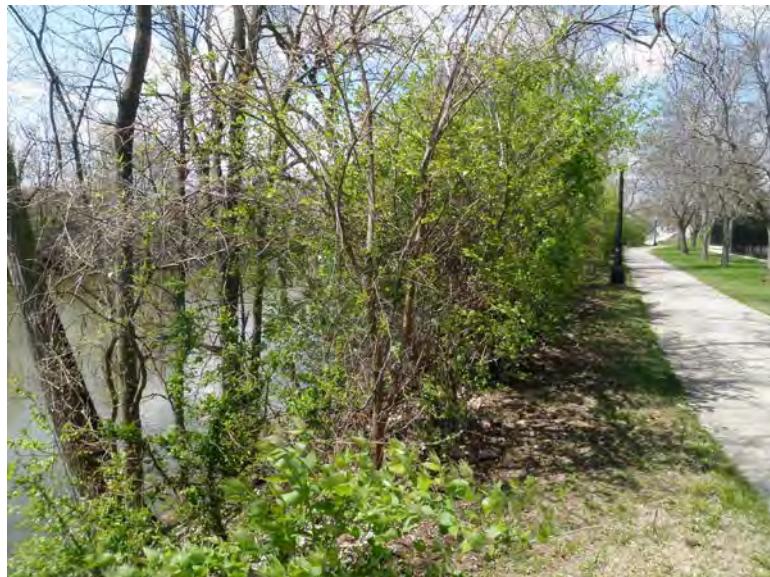
**Figure 3.22. Honeysuckle understory common on riparian slopes**  
 (Source: Biohabitats; April 30, 2015).

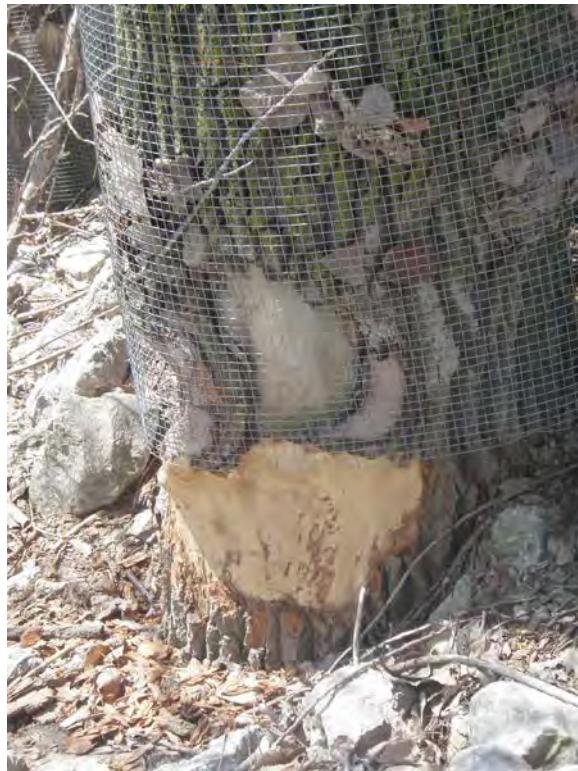
**Figure 3.23. Example of beaver protection that needs to be modified (Source: Biohabitats; April 30, 2015).**

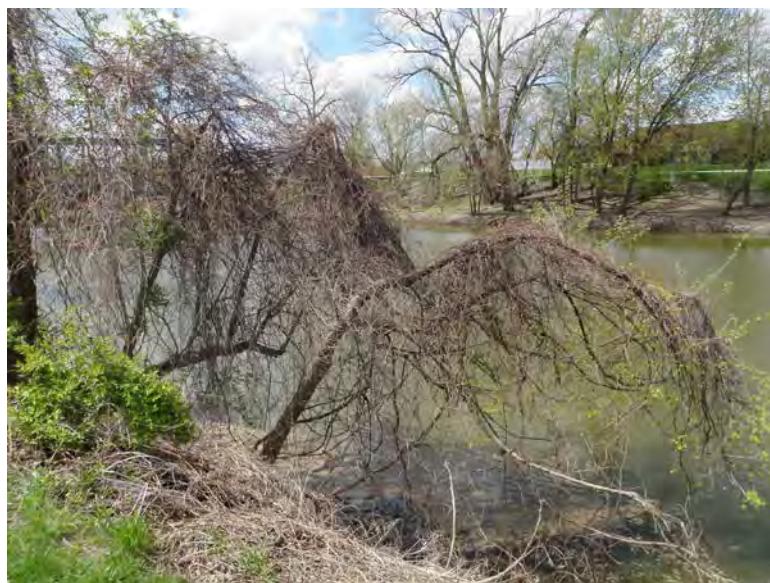
Vines can also impact views in a number of ways. They can block views by creating walls of green vegetation in the summer and brown vegetation in the winter. The weight of the vines can also pull down and damage or uproot trees. In other scenarios they can form a ground cover over the riparian slope, opening up views which may not be desirable. A common approach to removing climbing vines if they are not desired is to first cut the vine at ground level and then cut the vine again at eye level or higher. This way when the vine resprouts it will be difficult for the vine to gain a foothold in the tree again.

Figure 3.27. Vines pulling down trees along the St. Marys (Source: Biohabitats; April 30, 2015).

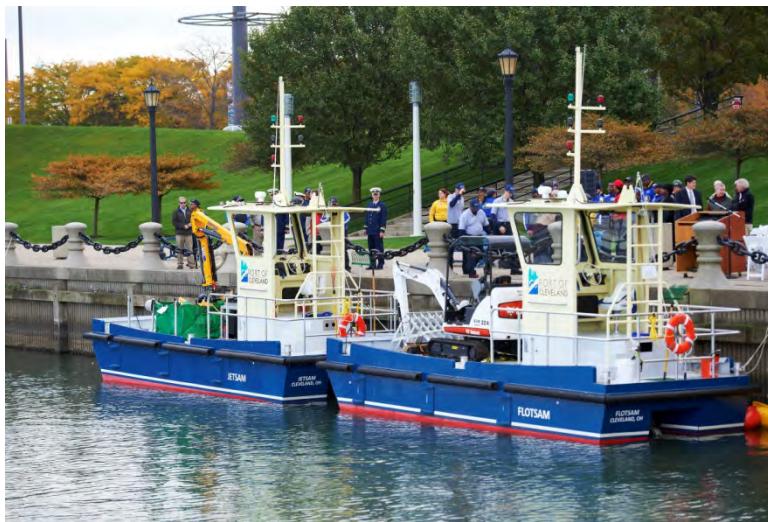
access is available. The two boats, Jetsam (w/attached crane) and Flotsam (w/attached excavator) are operated by the Port of Cleveland and can even be linked together to form one large platform (Figure 3.28).

Figure 3.28. Jetsam and Flotsam on the Cuyahoga River (Source: Port of Cleveland).

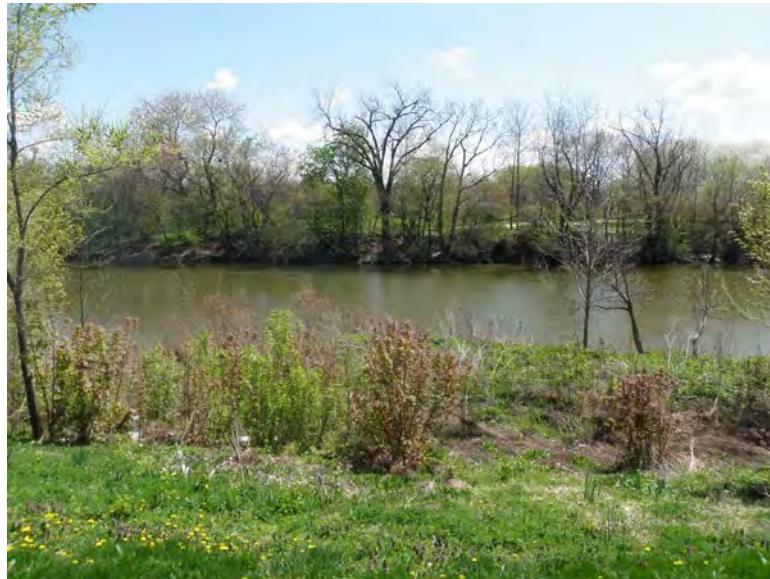
Figure 5.3. Viewshed with silver maple suckers (Source: Biohabitats; April 30, 2015).

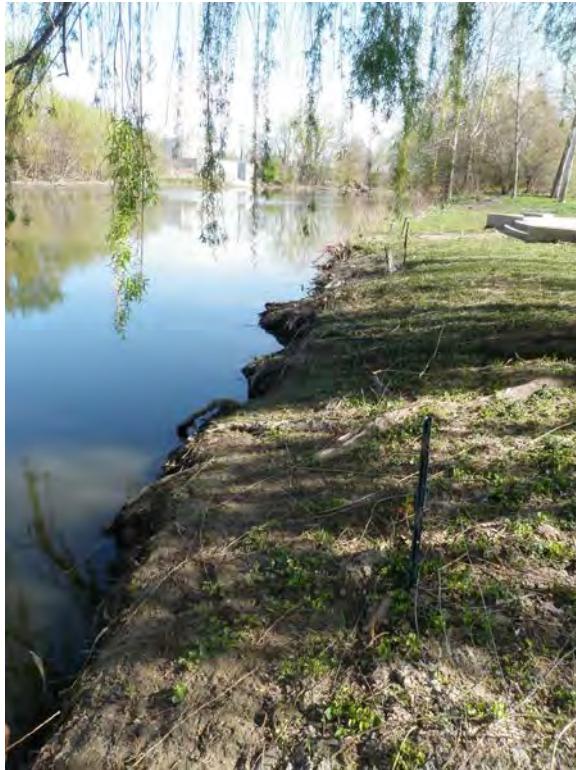
The conceptual plan leaves Headwaters Park alone for the most part, thus any activities related to restoration need to be closely coordinated with the Parks and Recreation Department. The two main concerns for Headwaters Park involve areas of streambank erosion, see Section 2.2.6. The area adjacent to the amphitheater is less severe, but is critical to address due to its high profile location and use as river access for boaters. Understanding that views to and from the river are important in this location, as well as aesthetics, the approach here needs to be minimal in size and scale. Based on the gentle slopes, the bank could be stabilized with coir logs and/or regraded. A dwarf variety of red osier dogwood (*Cornus sericea 'Insanti'*) that grows to 4-5 feet could then be planted along the water's edge to help stabilize the banks. If height is not a concern the native species could be used (8-10 feet in height). Plantings could be a combination of bioengineering materials and containerized stock, or herbaceous material if height is of concern. An alternative approach is to add a section of boulder toe at the access point to provide a more stable and formal access location. Conversely, the downstream erosion is much more severe and in immediate need of restoration. This location has already been discussed with IDNR as a potential grant project in the near future using a boulder bank/root pack approach (see Appendix I).

**Figure 5.5. Bank erosion at Headwaters Park near amphitheater**  
(Source: Biohabitats; April 30, 2015).

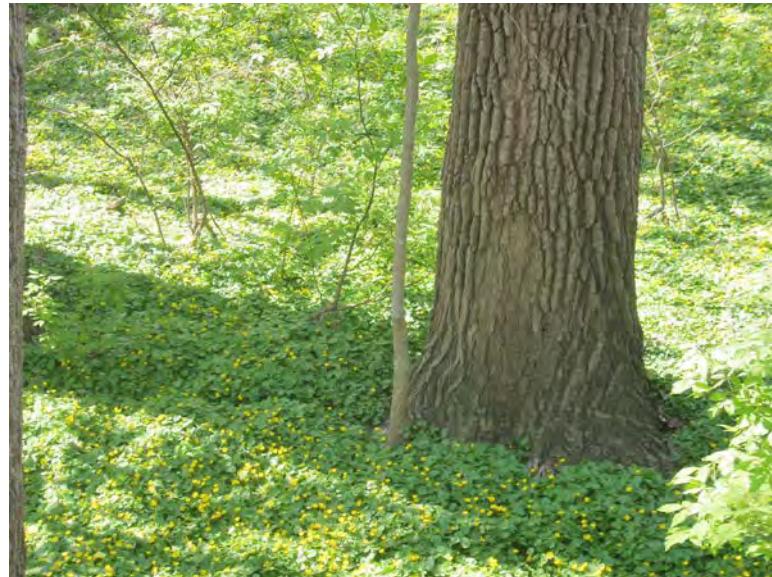
Figure 5.6. Lesser celandine infestation along Spy Run (Source: Biohabitats; April 30, 2015).

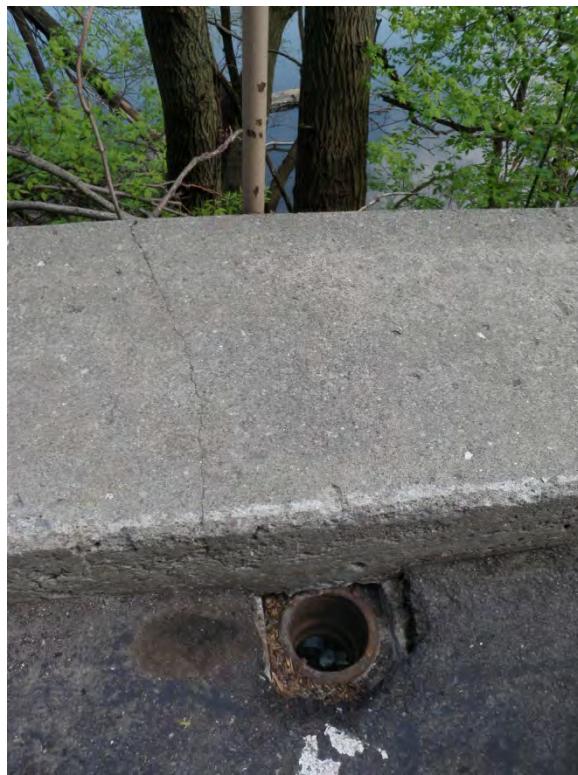
**Figure 5.8. Uncovered drains at the Three Rivers Apartments**  
(Source: Biohabitats; April 30, 2015).

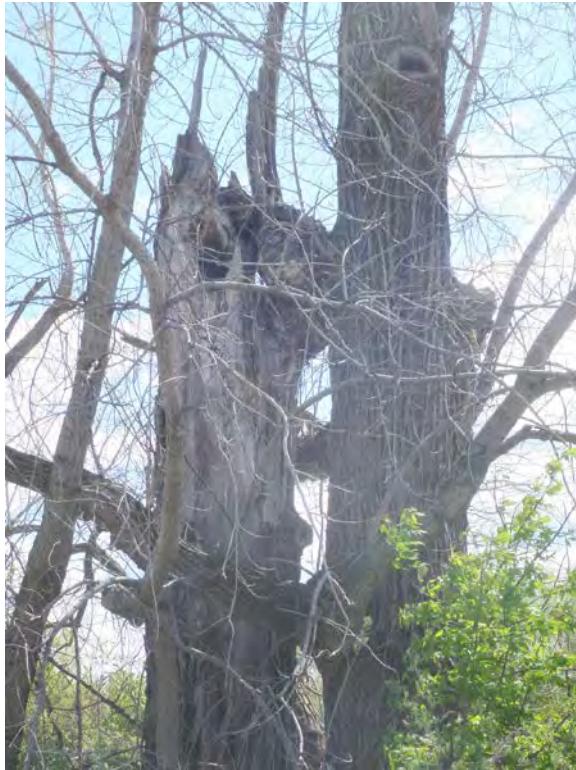
Buffer and streambank restoration also needs to adhere to the City's Overall Operation, Maintenance, Repair, Replacement, and Rehabilitation Manual (October 2002). Previously completed slopes and levees that were not cleared as part of the USACE project may remain with vegetation unless erosion and other natural causes remove the trees and shrubs. Once that vegetation is removed it cannot be replaced by woody vegetation however, vines are allowed in the planters that were installed in the rip-rap along the St. Joseph. A 15-foot buffer width of turf is also preferred adjacent to the levees, thus planting large trees near levees should be avoided. Regarding allowable tree removals, from a habitat perspective it is preferred that the rootwad and a portion of the trunk (10-foot minimum) be allowed to remain to provide standing snag habitat for birds and bats. Removing the upper stem will also significantly reduce the weight load on the snag, reducing the chance of uprooting it.

**Figure 5.9. Broken cottonwood tree still providing habitat on streambank (Source: Biohabitats; April 30, 2015).**

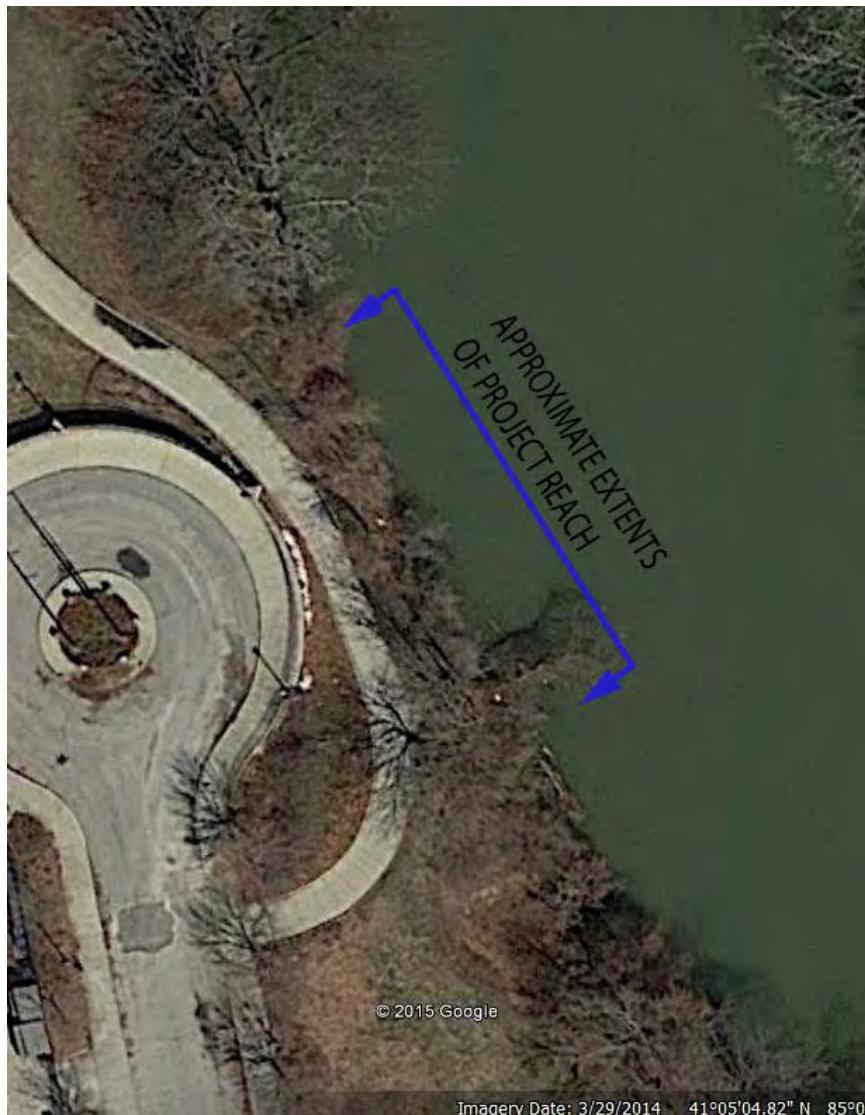
**Figure 8. Headwaters Park – Streambank erosion location.**

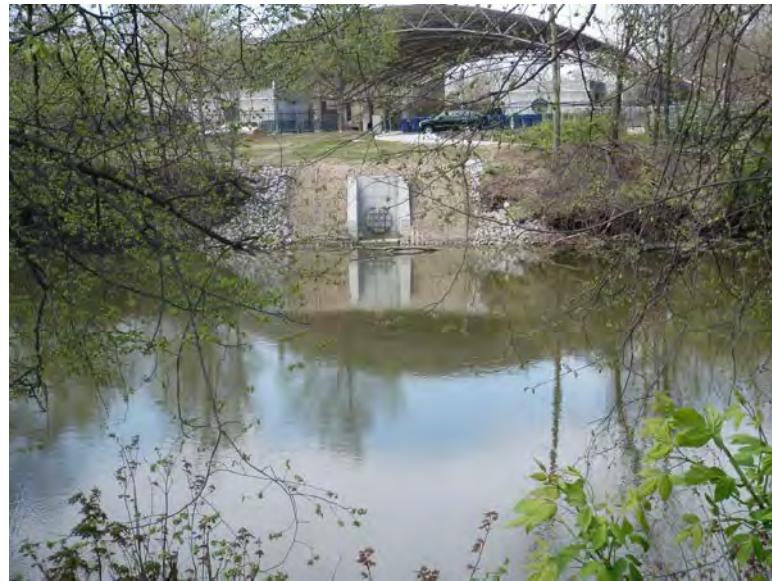
**Figure 9. New stormwater outfall.**

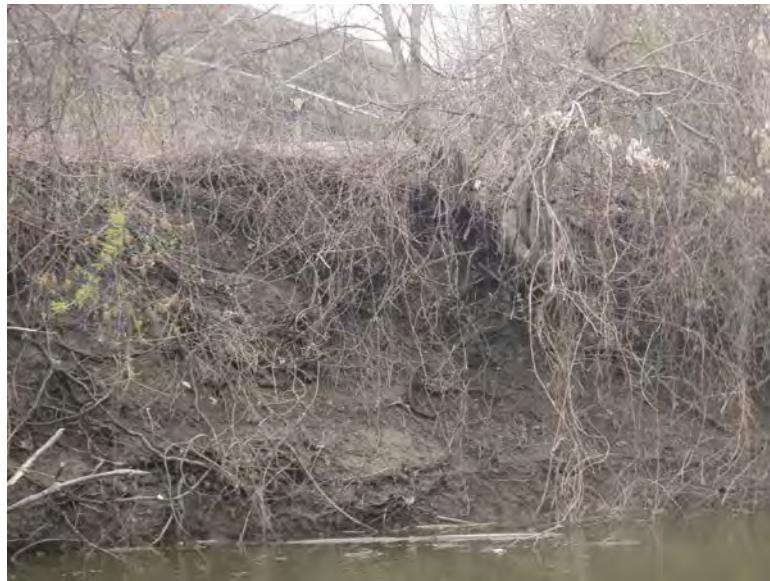
**Figure 11. Bank erosion below sidewalk.**
